AFWL-TR-77-274

## FRACTURE ANALYSIS OF REENTRY VEHICLE STRUCTURAL MATERIALS

September 1978

Final Report

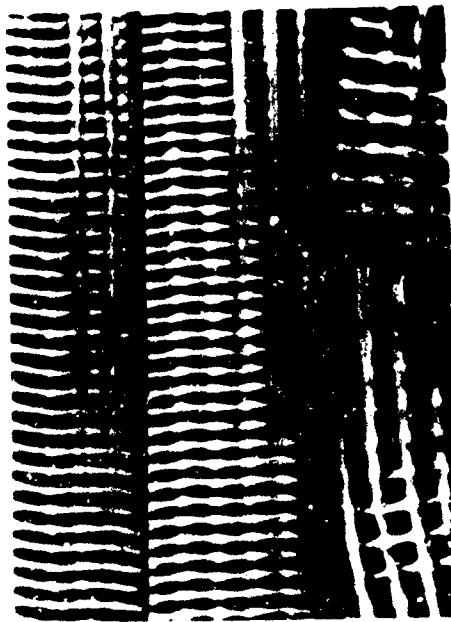
Figures 2 and 3 are photographs of the 3DQP specimens after test. As can be seen, the specimens subjected to dynamic testing ( $\dot{\epsilon} = 10^2$  cm/cm/sec) failed with somewhat more transverse shear. Fiber and fiber bundle pull-out was rather extensive on all the specimens and most of the specimens hung together after test by the intertwining of pulled out fibers.

Figure 1. Macroscopic Views of 300P Specimens. (a) Upper two specimens were cut from same ring at two different orientations; bottom specimen cut from different ring 2X. (b) Middle specimen 20X. (c) Bottom specimen 20X. (d) Upper specimen 20X.

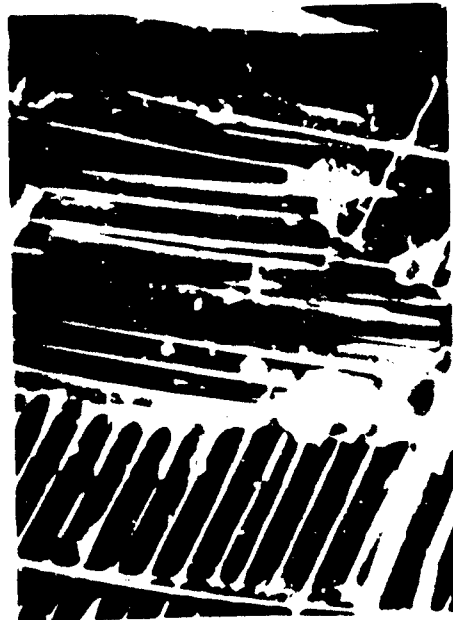
The 3DQP fracture surfaces were examined with the scanning electron microscope (SEM). Some of the photomicrographs taken with the SEM are shown in figures 4 and 5. Figures 4a and b and 5a and b were taken during a preliminary examination of the fracture surfaces and it was noted that the specimens which had been tested dynamically showed a much finer fracture pattern in the resin areas at high magnifications (compare figure 4b with figure 5b). Since low power photomicrographs of specimens did not appear much different (figures 4a and 5a), it was thought that the high power pictures might have been coincidental and were not representative. Thus, several additional specimens from both those that had been statically tested and those that had been dynamically tested were examined closely for this feature and it was found that those that had been tested dynamically consistently had a much finer fracture pattern in the resin areas compared with those which had been tested statically. Figures 4c and 4d of "static" tests and figures 5c and 5d of "dynamic" tests are other areas which clearly show this difference. No significant differences could be detected in the fiber areas of the specimens.

Two completely different and unrelated explanations are offered to account for this difference in the appearance of the fracture surface in the resin areas of the 3DQP when tested at these different strain rates. The first is that the resin, being a polymeric material, behaves like a viscous material, at least on the microscopic scale. Thus, when this material is loaded at a very low strain rate, i.e., static loading, the flaws or cracks in the material grow by a viscous flow or separation at the tip of the crack. Instead of a sharp crack propagating rapidly by a cleavage-like process, a blunt crack tip propagates by a flow of the material at the tip. This viscous flow leaves the relatively smooth fracture surface that was observed on the statically tested specimens. On the other hand, when the material is strained at a high strain rate, there is insufficient time for the necessary viscous flow and the resin fractures by the rapid propagation of all the flaws which are of the proper orientation and of sufficient size. These cracks then run together to produce the overall fracture surface on the resin pockets. It is the rapid propagation and joining of these cracks that give the fine structure of the fracture surface of the resin in the specimens which were tested dynamically.

Figure 4. Microscopic (SEM) Views of Resin Pockets in the Fracture Surfaces of 300P after "Static" Tests. (a) First area 200X. (b) Second area 500X. (c) Third area 1000X.

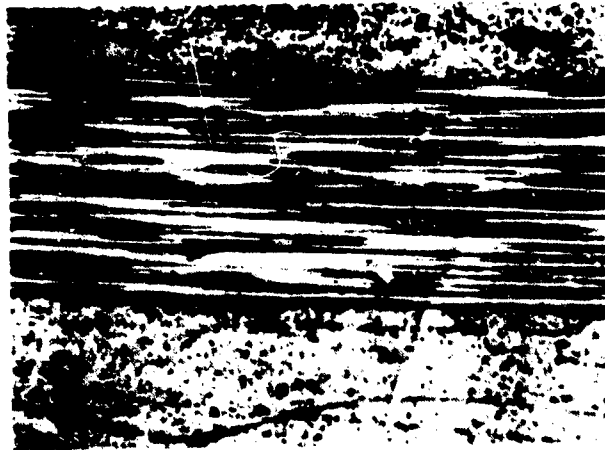
Figure 7. G/E Composite Showing Ply Boundaries. (a) Area Near Center of Specimen Showing Two Boundaries 100X. (b) Area Near Edge of Specimen Showing One Boundary 100X.

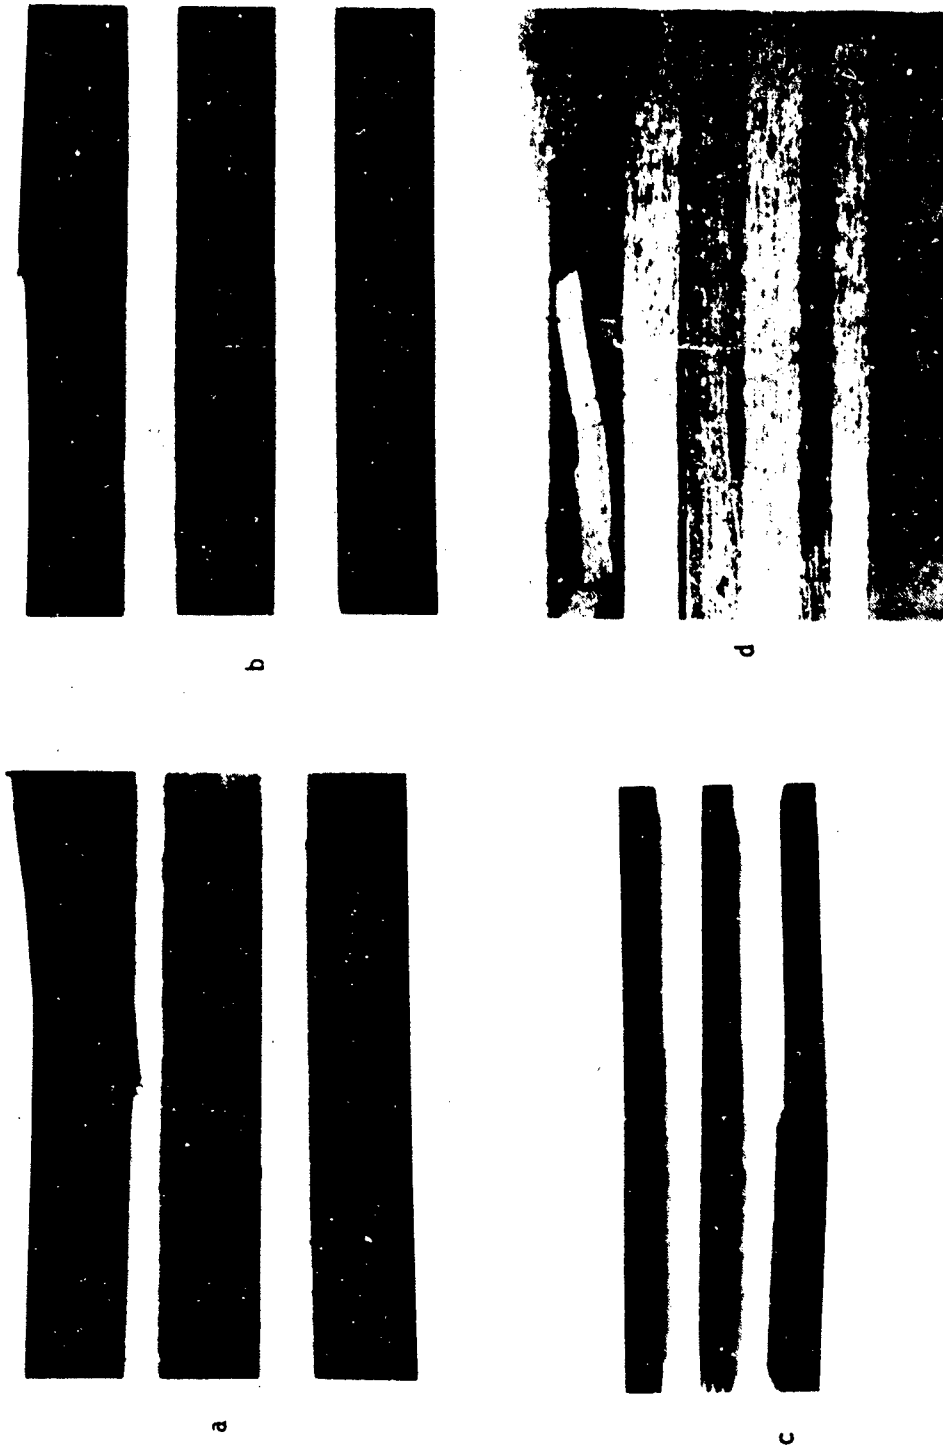
Visual examination of the specimens revealed that the "circumferential" specimens had less damage than the "axial" specimens. In the static test on the "circumferential" specimens, the outermost ply on the tensile side did not always fracture completely. As seen in figure 16, only a longitudinal split occurred on one specimen; on another, there was a transverse crack about one third of the way across the specimen, ending at a longitudinal split; and on the third "circumferential" specimen tested statically, there was a transverse crack across the specimen. All of the "circumferential" specimens tested statically had a transverse crack across the compression side of the specimen directly under where it was loaded. Two of these specimens appeared to have a fair amount of residual strength. Although the statically tested "circumferential" specimens had delamination, it was considerably less than most of the other specimens - less than all the "axial" specimens, and less than the "circumferential" specimens tested dynamically.

Figure 16. G/E Specimens After Test; Virgin Material, Static Test, "Circumferential" Orientation. (a) Tensile Side 2X. (b) Compression Side 2X. (c) Edge View 2X. (d) Edge View 20X.

parts still hung lightly together. There appears to be finer delamination in the dynamically tested specimens versus the statically tested ones - compare figure 17d with figure 16d.

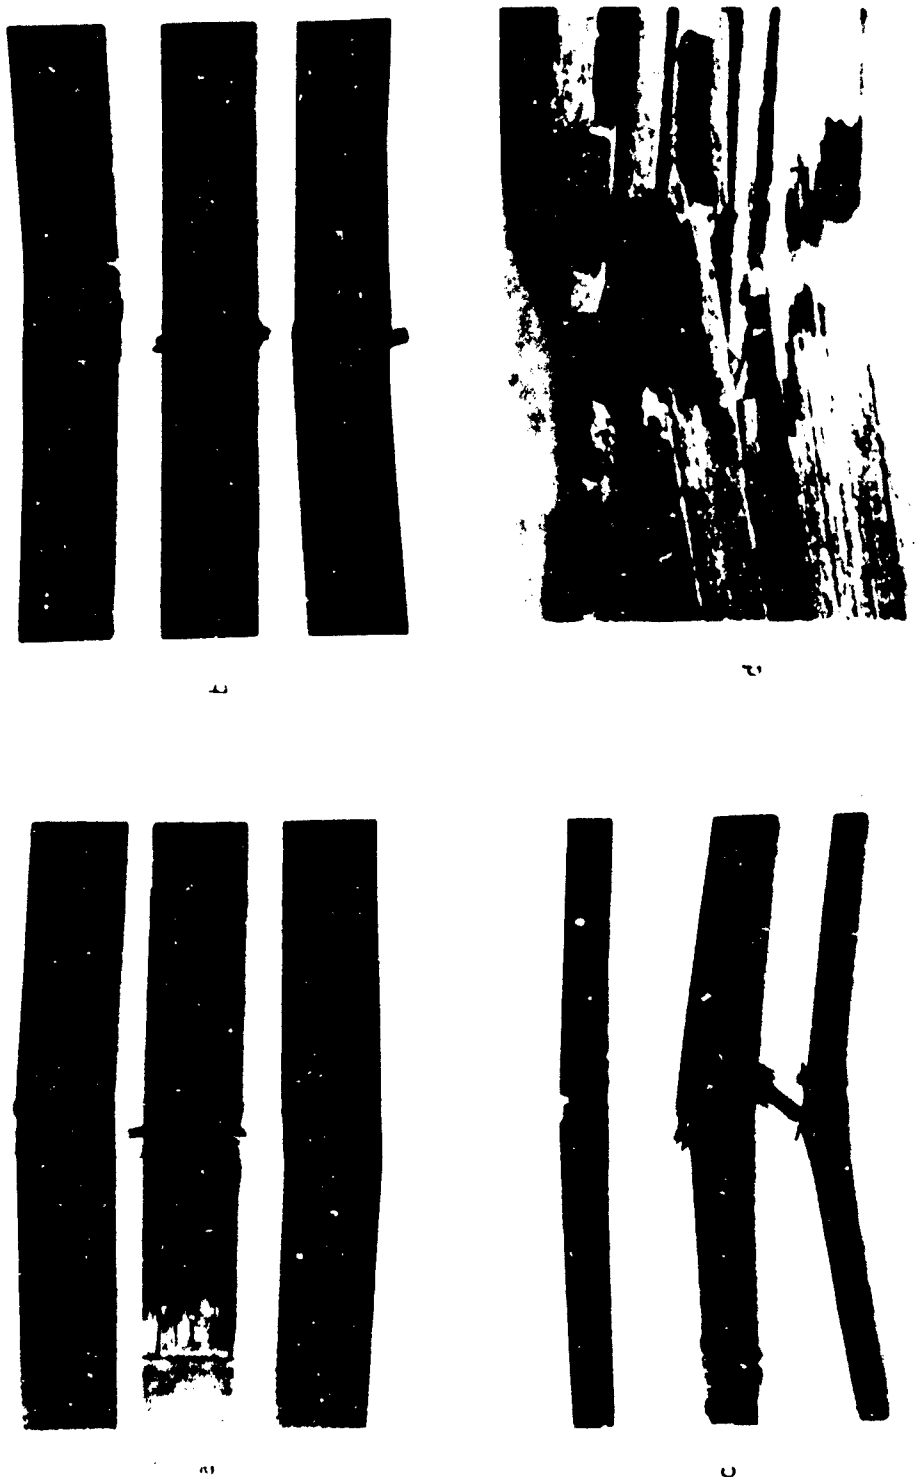
The dynamically tested "circumferential" specimens made of virgin material are shown in figure 17. In all of these specimens, the outermost fiber plies fractured and the specimens essentially broke into two parts although the two

Figure 17. G/E Specimens After Test; Virgin Material, Dynamic Test, "Circumferential" Orientation.  
 (a) Tensile Side 2X. (b) Compression Side 2X. (c) Edge View 2X. (d) Edge View 20X.

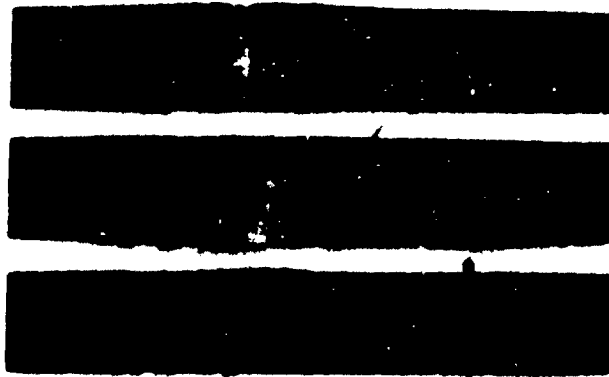
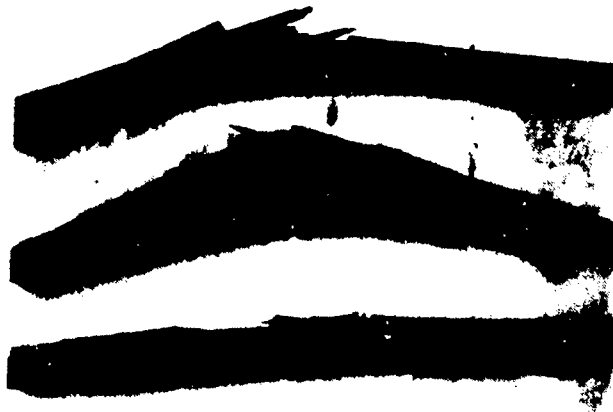
The statically tested "axial" specimens are shown in figure 18 and the dynamically tested "axial" specimens are shown in figure 19. There was not a substantial difference between the visual appearance of the statically tested and dynamically tested "axial" specimens. In all of the specimens, the outermost five plies (one layer of 90° and one layer of 0° plies) remained intact on the compression side and all of the remaining plies fractured. Again, there was a considerable amount of delamination which occurred on all specimens.

Figure 18. G/E Specimens After Test; Virgin Material, Static Test, "Axial" Orientation. (a) Tensile Side 2X. (b) Edge View 2X.

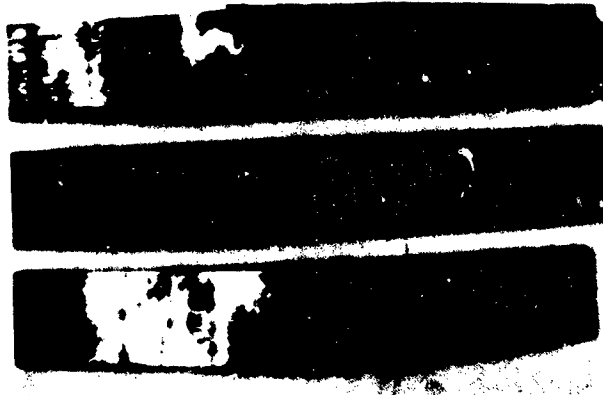
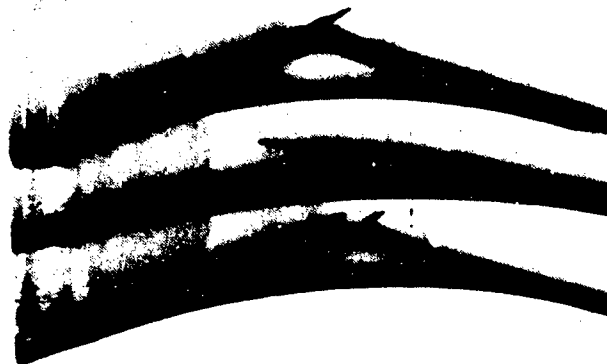
Figure 19. G/E Specimens After Test; Virgin Material, Dynamic Test, "Axial" Orientation. (a) Tensile Side 2X. (b) Edge View 2X.

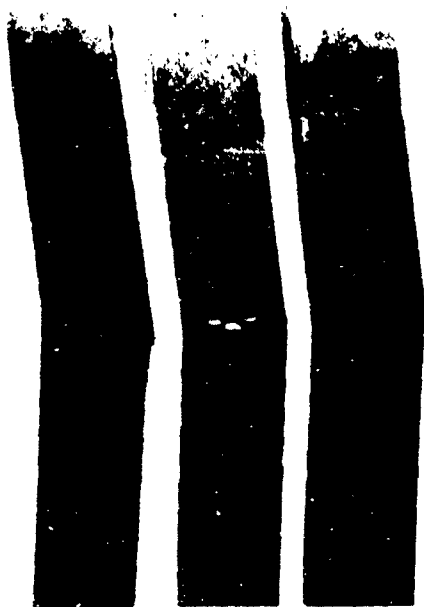
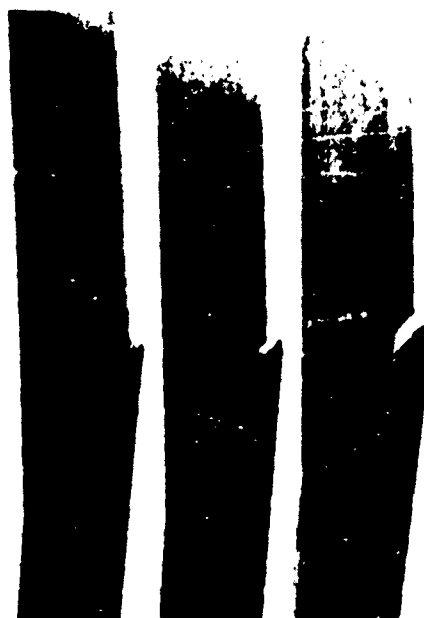
Photographs of the fractured TWCP specimens are shown in figures 29, 30, 31, and 32. As can be seen by comparing figure 29 with figure 30 or comparing figure 31 with figure 32, there is no apparent macroscopic difference between the statically tested and dynamically tested specimens. However, if one compares figure 29c with figure 31c or figure 30c with figure 32c, it can be seen that the fracture path followed a slightly different angle in the degraded material than in the virgin material. The angle (to the axis of the specimen) of the fracture path of the virgin material was 29 to 30° whereas the angle in the degraded material was 23° to 24°.

Figure 29. TwCP Specimens After Test; Virgin Material, Static Test. (a) Edge View of "Circumferential" Orientation Specimens 2X. (b) Closeup of (a) 8X. (c) Edge View of "Axial" Orientation Specimen 2X. (d) Fracture Surface of "Axial" Specimen 8X.

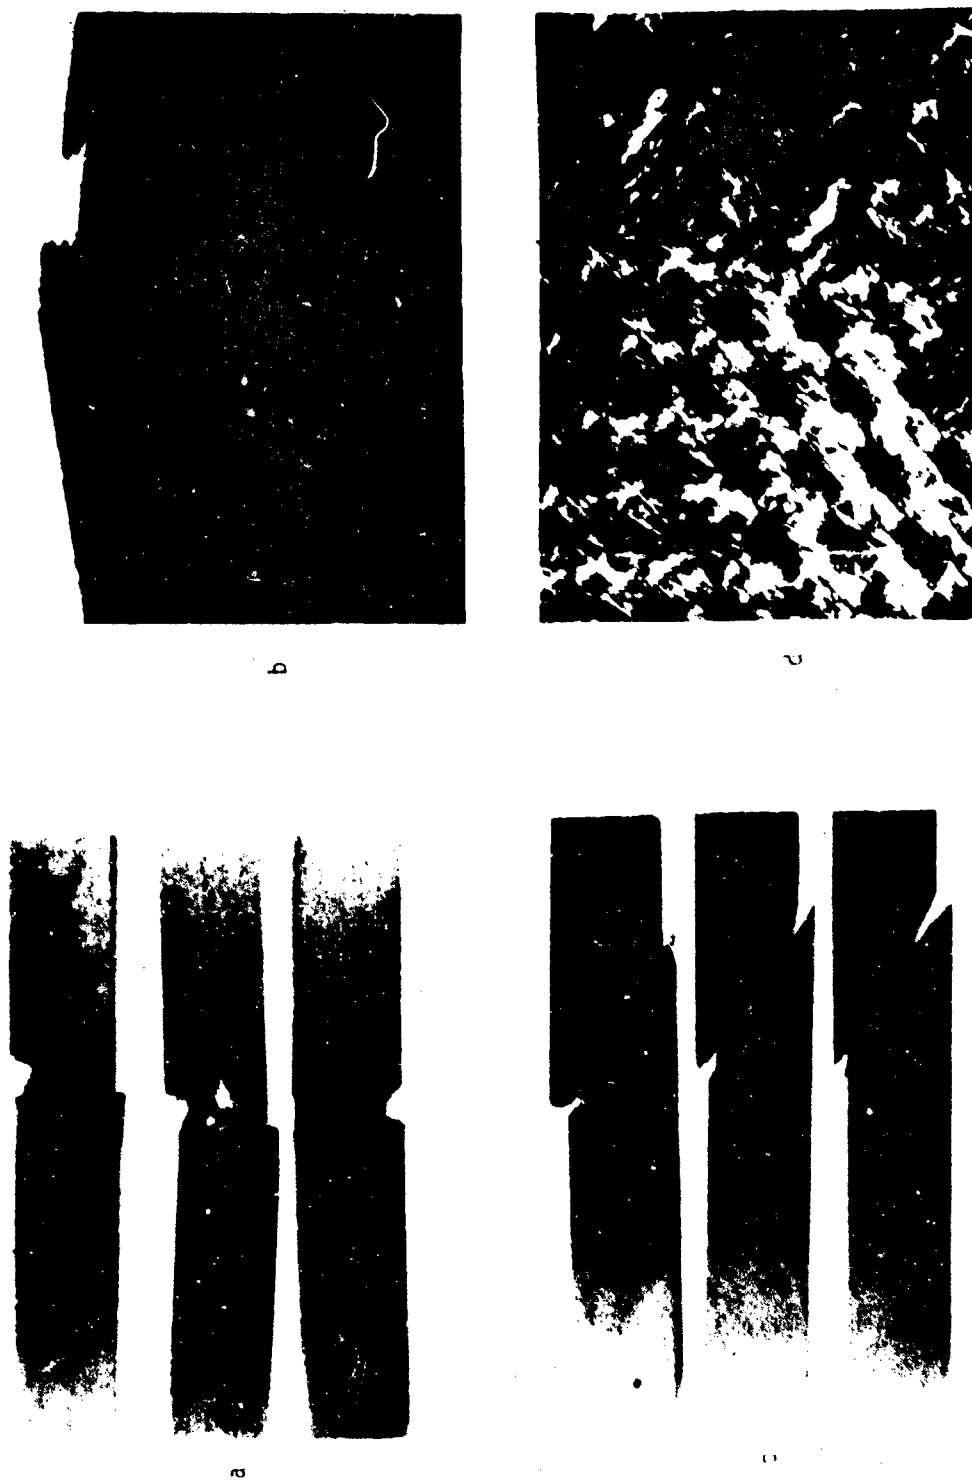
Figure 30. TWC Specimens After Test; Virgin Material, Dynamic Test. (a) Edge View of "Circumferential" Orientation Specimens 2X. (b) Closeup of (a) 8X. (c) Edge View of "Axial" Orientation Specimen 2X. (d) Fracture Surface of "Axial" Specimen 8X.

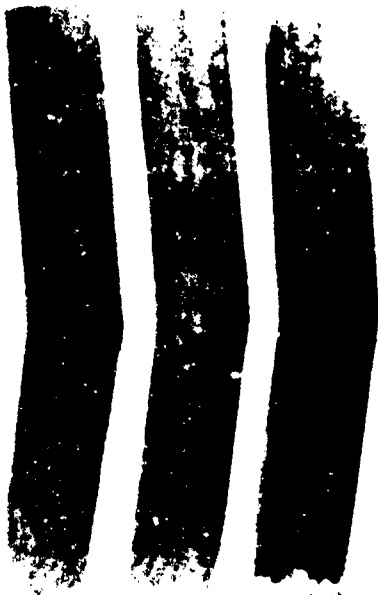
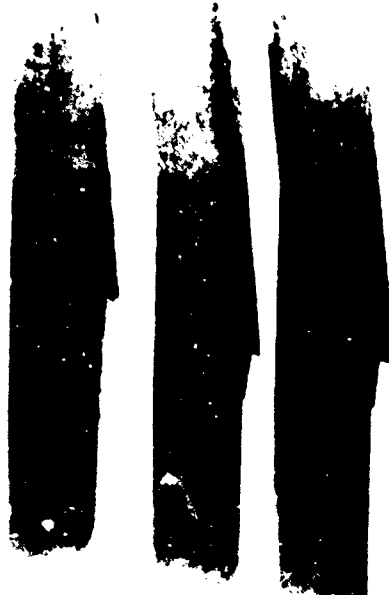
This difference in fracture angle between the virgin material is probably due to the presence of microcracks in the degraded material. Pre-test examination of the degraded material revealed microcracks in a majority of the specimens and it is felt that had the specimens been polished more and/or examined at higher magnification, microcracks would have been observed in all of the specimens. This material was laid up at a 20° angle of the plies to the axis and the interlaminar strength is the weakest. Thus, the angle of weakest material is 20°, but the angle of maximum stress in a three point bend test is 90° to the axis. Thus, the actual fracture path occurs somewhere between these two extremes and apparently resolved itself to approximately 30° for the virgin material. In the degraded material, on the other hand, microcracks formed on the interlaminar planes as a result of the one-dimensional shock loading from the simulated X-ray exposure. These microcracks made the already weakest plane

Figure 31. TWP Specimens After Test; Degraded Material, Static Test. (a) Edge View of "Circumferential" Orientation Specimens 2X. (b) Closeup of (a) 8X. (c) Edge View of "Axial" Orientation Specimen 2X. (d) Fracture Surface of "Axial" Specimen 8X.

still weaker. Thus, the fracture path would be expected to follow a path closer to the layup than it did in the virgin material. This agrees with the observed value of  $23^\circ$  to  $24^\circ$  for the degraded compared with  $29^\circ$  to  $30^\circ$  for the virgin material.

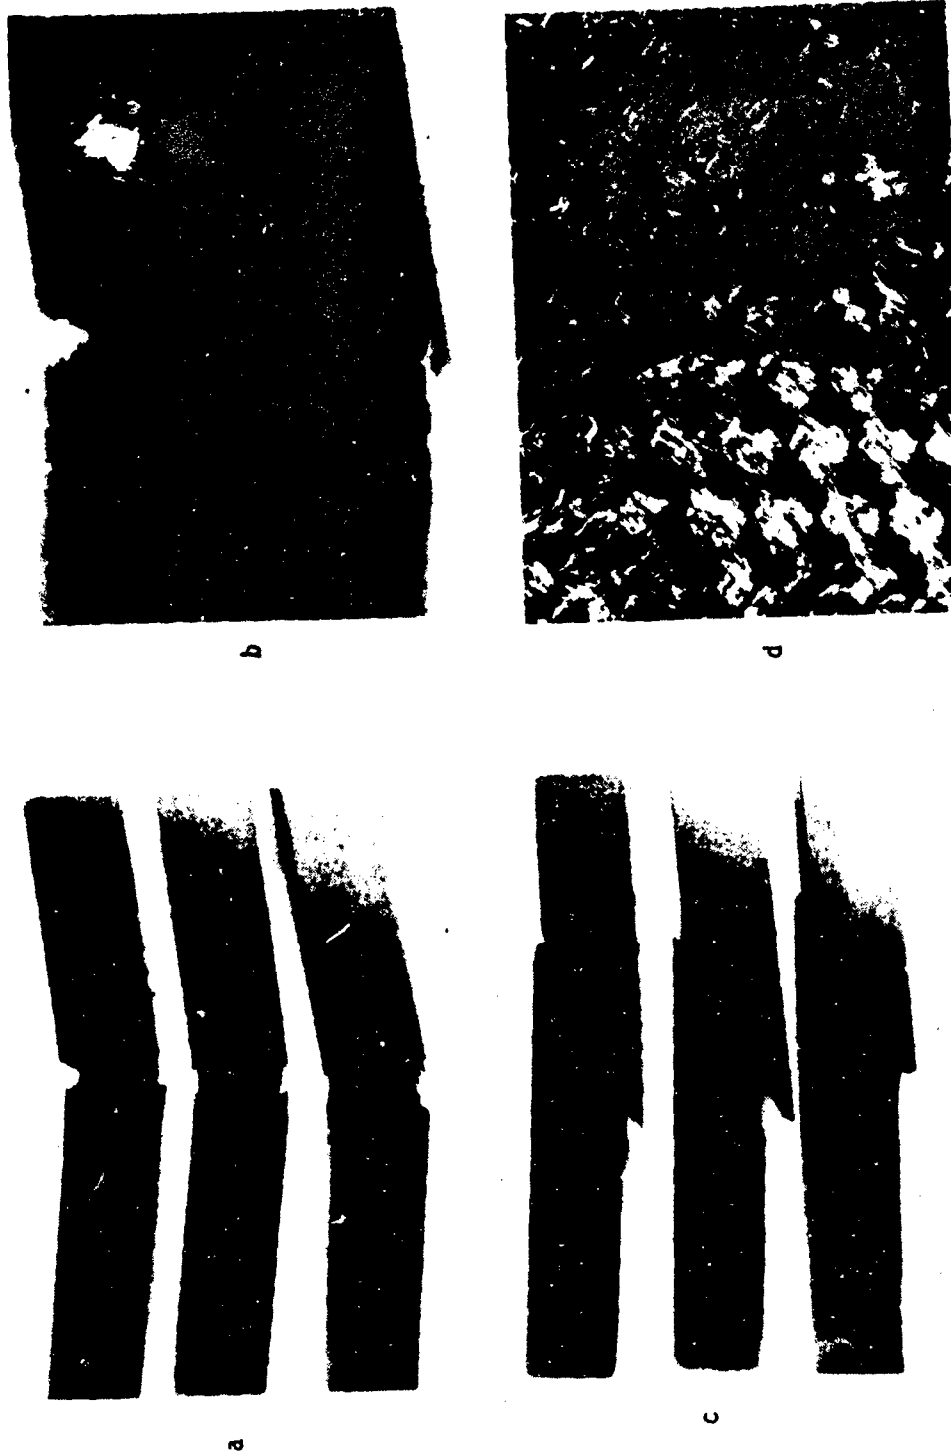
Figure 32. TWCP Specimens After Test; Degraded Material, Dynamic Test. (a) Edge View of "Circumferential" Orientation Specimens 2X. (b) Closeup of (a) 8X. (c) Edge View of "Axial" Orientation Specimen 2X. (d) Fracture Surface of "Axial" Specimen 8X.
